THE EFFECT OF THE 1857 FORT TEJON EARTHQUAKE
ON TREES NEAR WRIGHTWOOD, CALIFORNIA

Kristian E. Meisling and Kerry E. Sieh

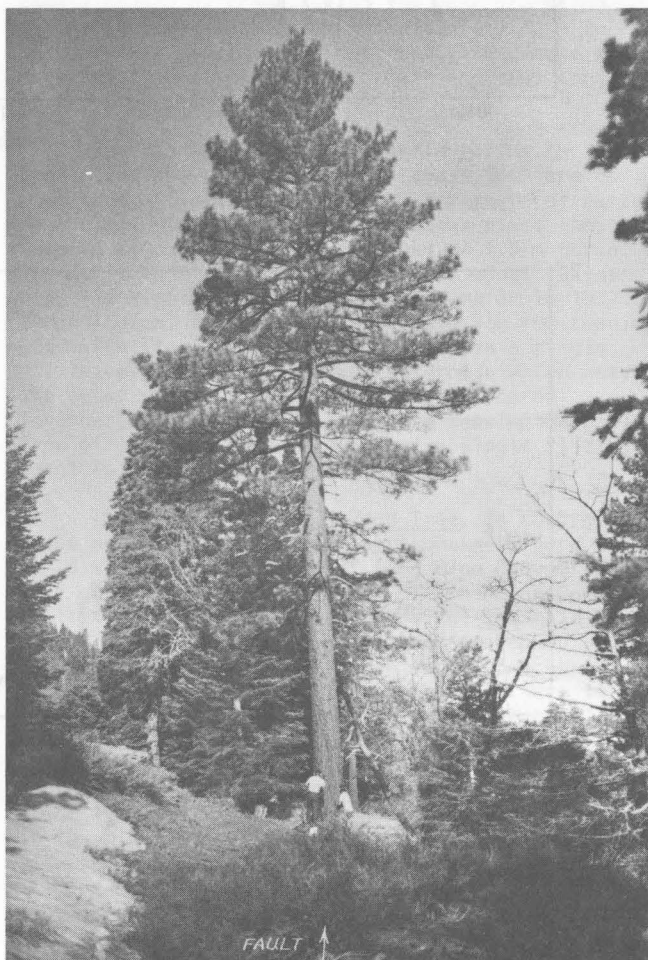
A healthy Jeffrey Pine, the Sidehill Bench Tree, is growing astride the San Andreas fault on a fault-related sidehill bench northwest of Big Pines (Figure 1). A core taken from the northwest side of the tree reveals a scar involving the growth rings of the years 1855-57; the 1856 and 1857 rings are missing altogether (Figure 2, WRW 35). In other cores a growth minimum is evident in 1857 (Figure 2 WRW 36).

Figure 1. Sidehill Bench Tree. Stump Tree hidden by brush in foreground.

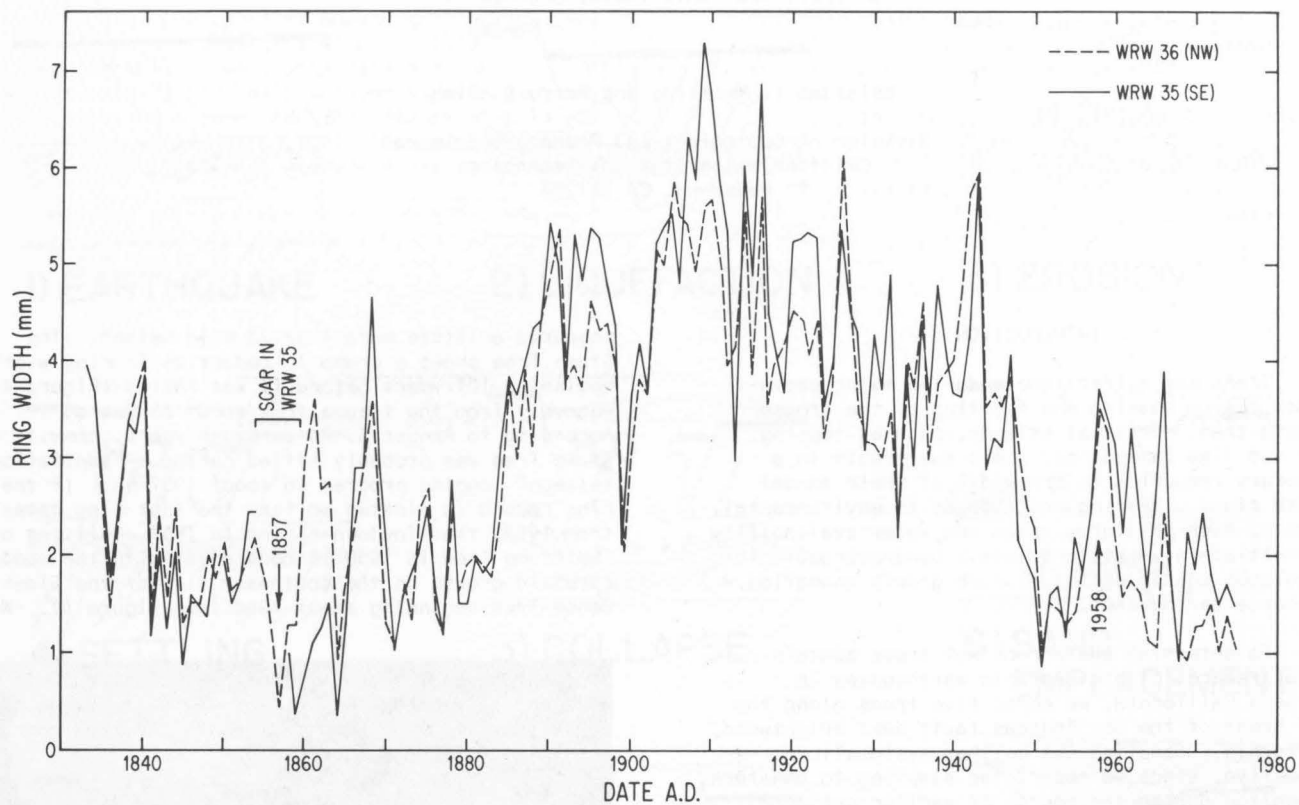
Figure 2. Sidehill Bench Tree ring width.

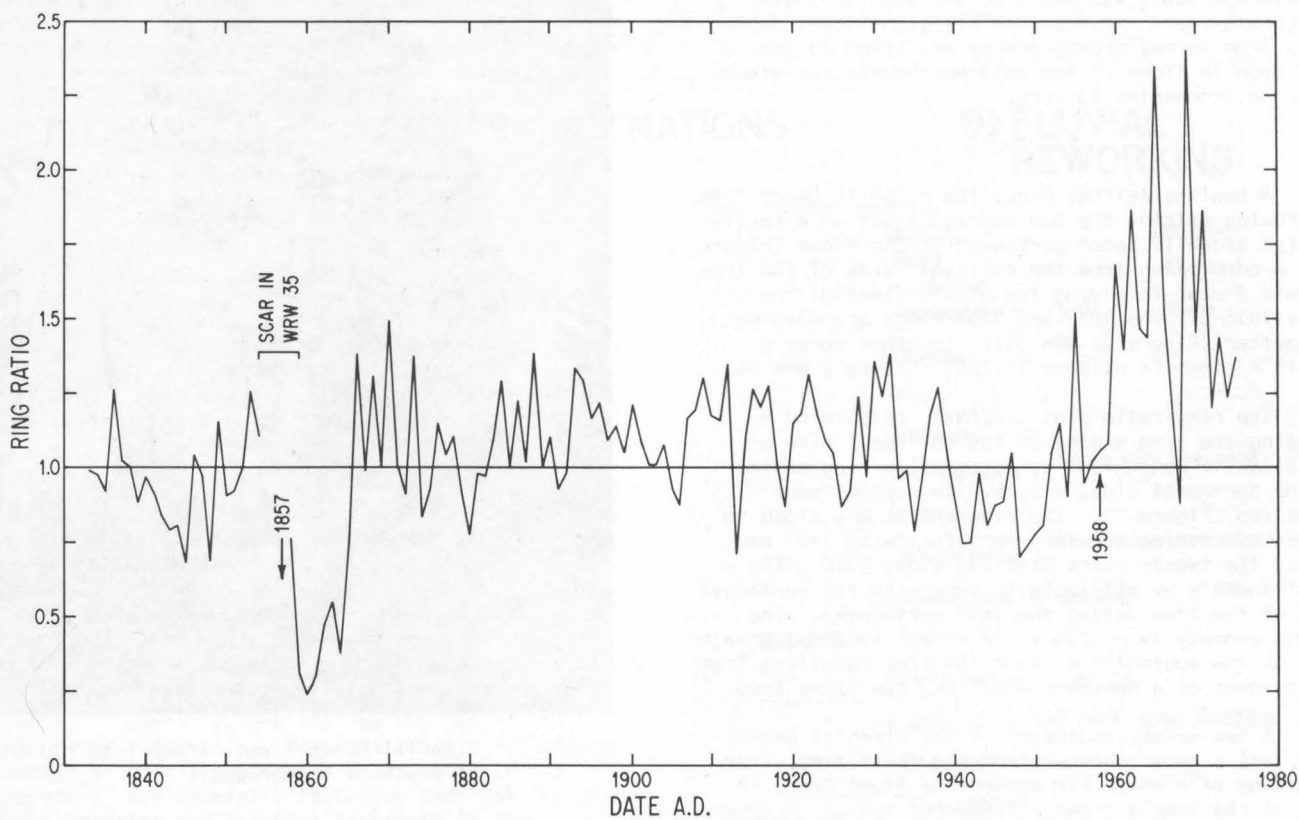
The ring-ratio plot (SE/NW), calculated by dividing the ring widths on the southeast side of the Sidehill Bench Tree by correlative ring widths on the northwest side, displays two conspicuous anomalies (Figure 3). The ring ratios are close to 1.0 except during the ten years following 1857 and during the twenty years starting about 1960. The first anomaly we attribute to damage to the northwest side of the tree during the 1857 earthquake. The second anomaly is probably due to an increased growth rate on the southeast side of the tree resulting from the removal of a nearby competitor, the Stump Tree.

Figure 3. Sidehill Bench Tree ring ratio.

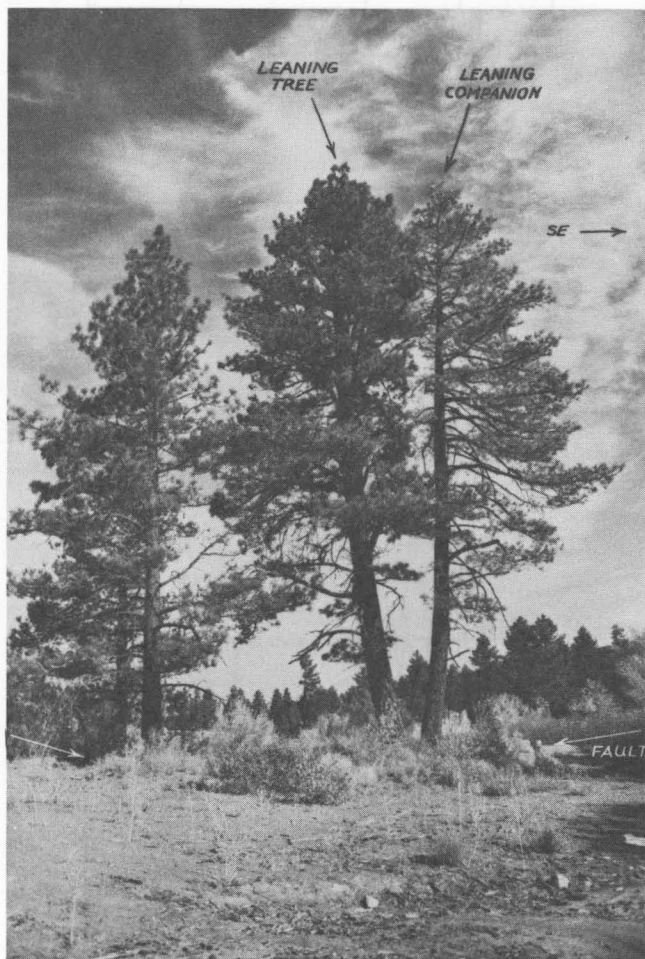
In Wrightwood, a pair of Jeffrey Pines are located on a low, linear mound southeast of the engineered levee of Heath Creek (Figure 5). They lean away from each other and show a pronounced asymmetry of both trunk and crown. Bends occur in the trunks of both the Leaning Tree and the Leaning Companion Tree. The lower 7.5 to 12 m of the Leaning Tree tilts 12° to the northwest; above 12 m the trunk tilts considerably less. The Leaning Companion Tree tilts 13° to the southeast below an abrupt bend in the trunk at about 3.5 m; above this bend the trunk is nearly vertical. These effects could be the result of mutual competition for space and light, but, because both trees are rooted in the fault zone, we suspected that the tilts might also be related to the 1857 earthquake. Eight cores were taken from the Leaning Tree and one from the Leaning Companion.

Morphological features and ring data for both the Leaning Tree and the Leaning Companion Tree are consistent with a single tilting event in 1857. The Leaning Tree was about 20 years old, 10 m high and about 15 cm in diameter at the time of the earthquake. We propose that the 20-year ring-ratio anomaly reflects trauma caused by root or limb damage suffered during fault slippage underfoot in 1857. After recovery, the tree's shifted center of gravity led to increased growth on the northwest side relative to the southeast side. The competitive influence of the Leaning Companion Tree heightened the tendency. The asymmetry of the Leaning Tree actually began in 1856. According to available rain records, 1856 was a moderately dry year, but response to water shortage should not have been asymmetric. Although it is tempting to interpret this early onset of trauma as evidence of root damage caused by creep during the year preceding the earthquake, there are not sufficient data to warrant this conclusion. Pest and wind damage might have resulted in asymmetric growth and thus cannot be ruled out.

The Leaning Companion Tree is rotten in the center and the rings older than about 1869 are not preserved. It is not clear how many years of early record are missing, but our estimates place the Leaning Companion Tree at a height of 1.5 m during the early 1840's. Thus the tree was about 15 years old, 4 m high and about 10 cm in diameter in 1857. Morphological features and ring data for the Leaning Companion Tree are also consistent with a single tilting event in the mid-1800's through which only the outer rings survived intact. Considered together, the Leaning Tree and the Leaning Companion Tree offer compelling evidence of a single tilting event in 1856-57.

Figure 5. Leaning Tree and Leaning Companion Tree.

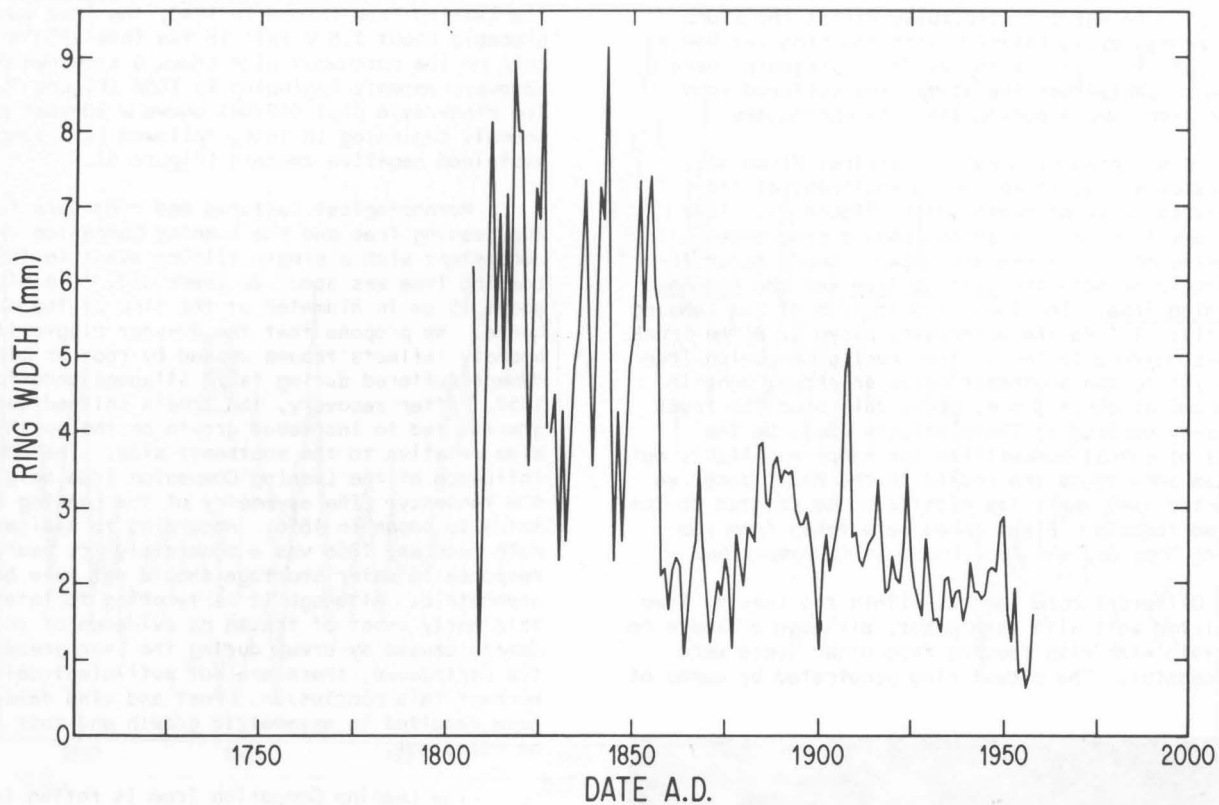
measured a little more than 23 m in height. The Stump Tree shows a dramatic reduction in ring width beginning 101 years before it was felled (Figure 4). Recovery from the trauma took about 25 years. According to Ranger S. R. Carbaugh (pers. comm.), the Stump Tree was probably killed during a "sanitation salvage" logging program in about 1957-58. If the ring record is plotted so that the last ring dates from 1958, the slowdown begins in 1857. Killing of the Stump Tree in 1958 is consistent with the sudden burst in growth on the southeast side of the Sidehill Bench Tree beginning about 1960 (see Figure 3). We

were not successful in precisely dating the Stump Tree records by correlation with the Sidehill Bench Tree; but, in light of the evidence presented herein, it seems likely that the Stump Tree suffered root and/or limb damage during the 1857 earthquake.

Figure 4. Stump Tree ring width.

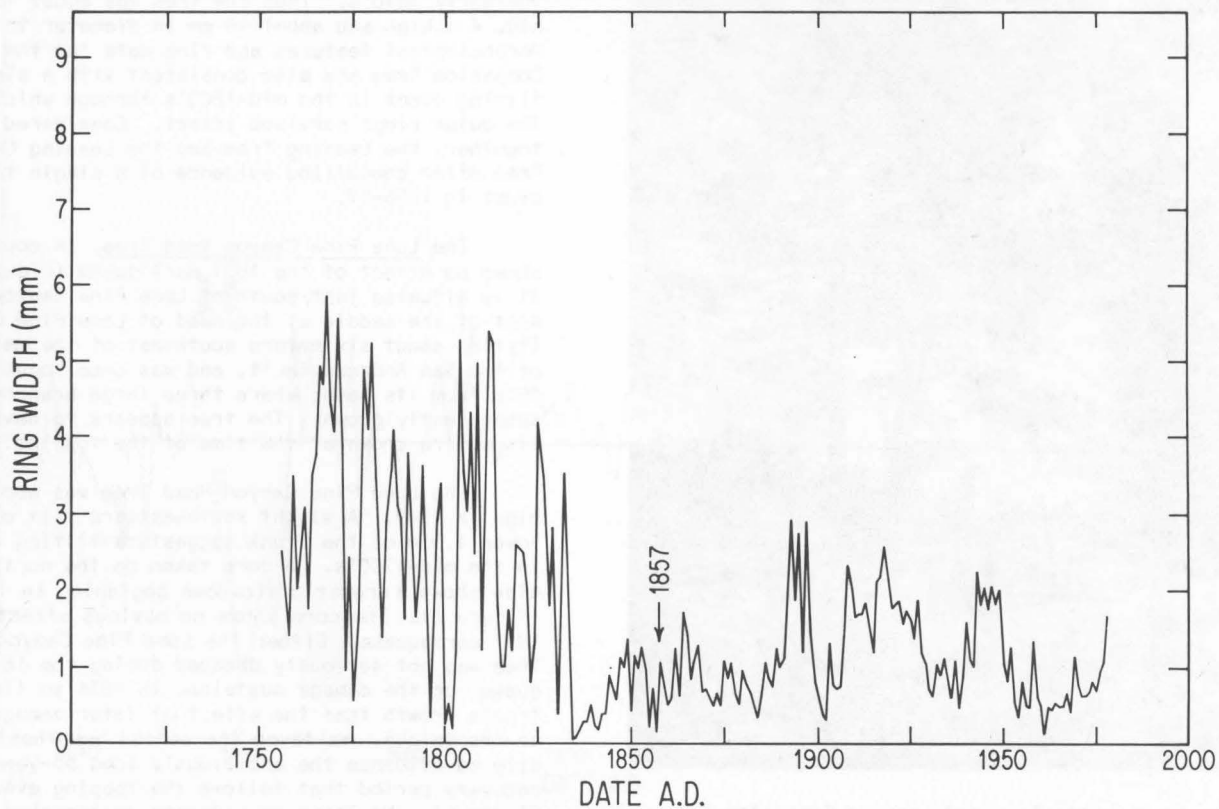
The Lone Pine Canyon Road Tree was about 1.5 m high in 1749. A slight southwestward tilt of the lower 1.5 m of the trunk suggests a tilting event in the mid-1700's. A core taken on the northeast side shows a dramatic slowdown beginning in 1834 (Figure 6). The core shows no obvious effect of the 1857 earthquake. Either the Lone Pine Canyon Road Tree was not seriously damaged during the 1857 earthquake, or the damage sustained in 1834 so limited the tree's growth that the effect of later damage cannot be recognized. We favor the second hypothesis, and cite as evidence the anomalously long 55-year recovery period that follows the topping event (see Figure 6). No large or moderate earthquakes are recorded for this region in 1834, so we conclude that the tree was probably topped by lightning or wind in 1834.

Figure 6. Lone Pine Canyon Road Tree ring width.

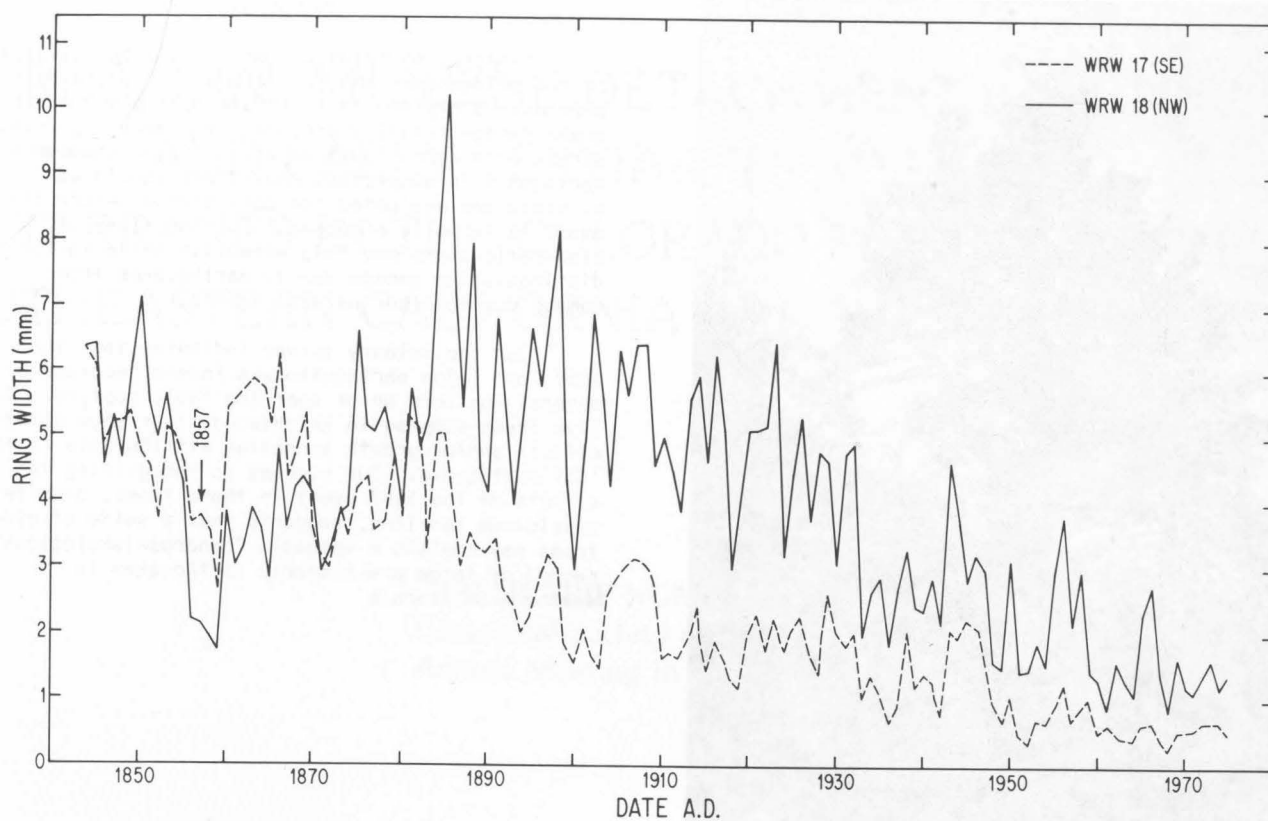
the Leaning Tree formed in 1846; the tree was probably about 1.5 m tall in the late 1830's. One core on the northwest side shows a slowdown and recovery anomaly beginning in 1856 (Figure 7, WRW 18). The ring-ratio plot (SE/NW) shows a 20-year positive anomaly beginning in 1856, followed by a long sustained negative anomaly (Figure 9).

Figure 7. Leaning Tree ring width.

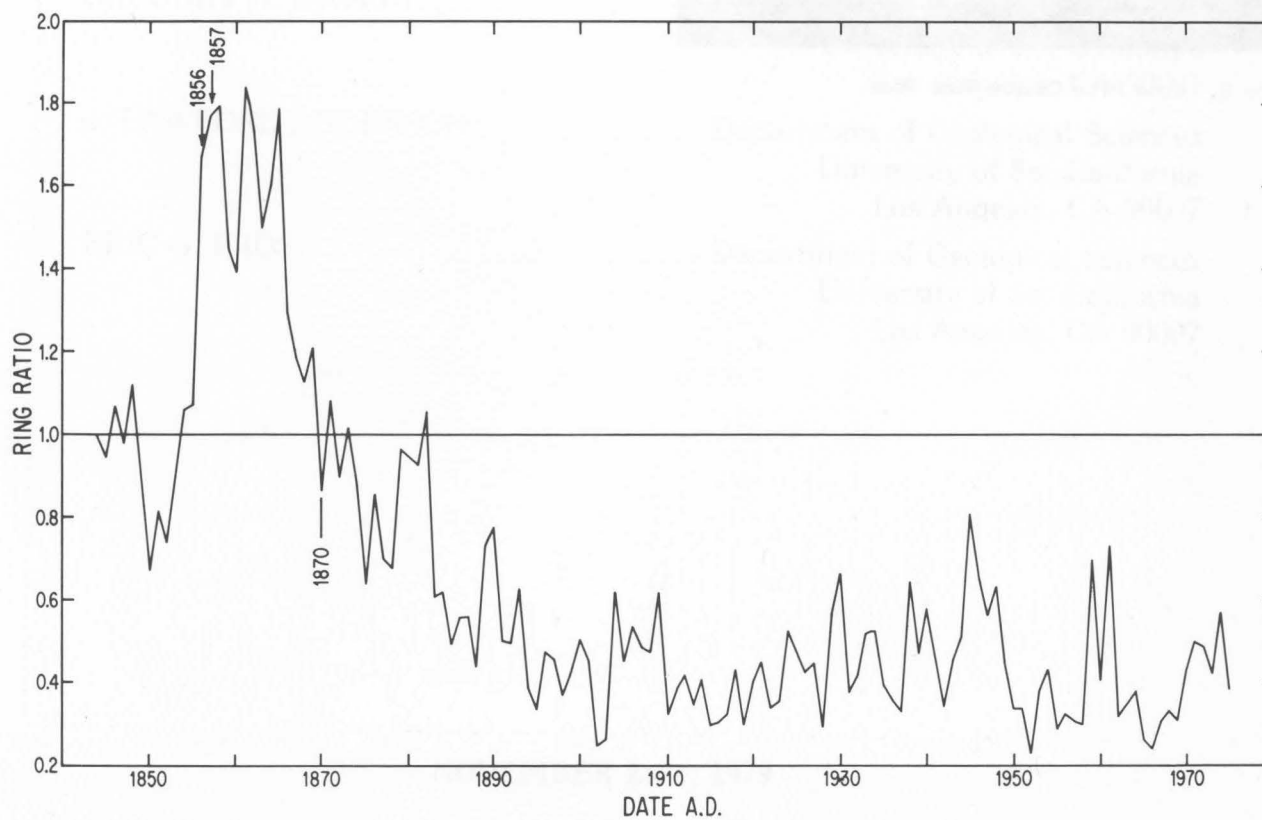
Figure 9. Leaning Tree ring ratio.

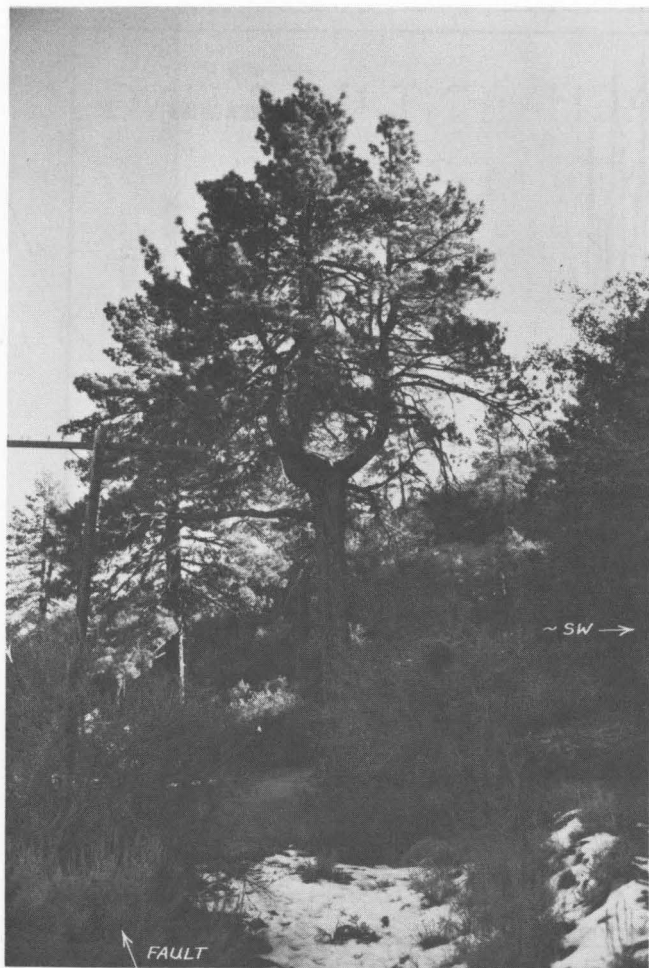
The Lone Pine Canyon Road Tree, in contrast, shows no effect of the 1857 earthquake (Figure 8). It is situated just south of Lone Pine Canyon Road, west of the saddle at the head of Lone Pine Canyon. It lies about six meters southwest of the main trace of the San Andreas fault, and was once topped about 15 m from its base, where three large branches have subsequently grown. The tree appears to have lost its entire crown at the time of the topping.

Figure 8. Lone Pine Canyon Road Tree.
